FIREGROUND FACTORS & POST-INCIDENT COMMENTS:

Introduction - As we internally review this incident our focus is placed on what can be learned to help improve and prevent this type of tragedy for the fire service in the future.

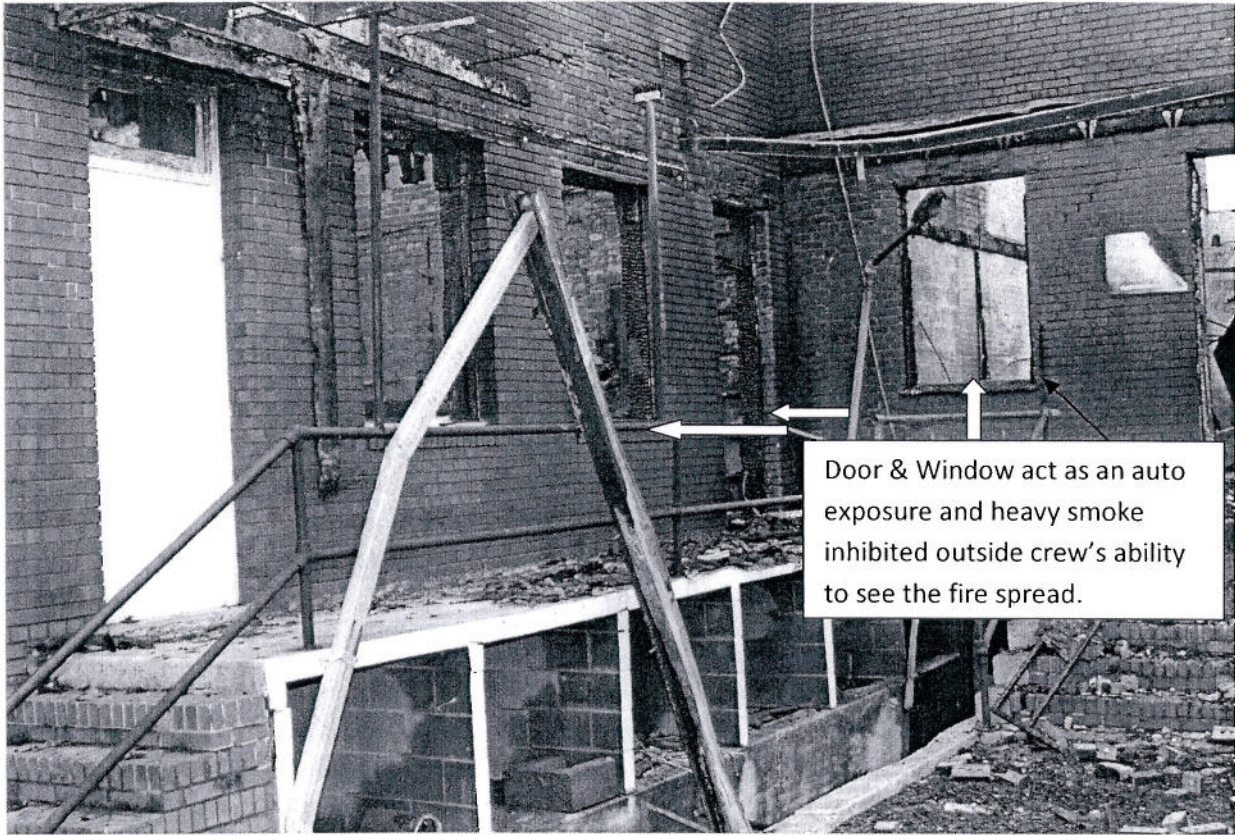
Photo "A" - View of Delta side office and Alpha side loading dock area leading into the tool room.

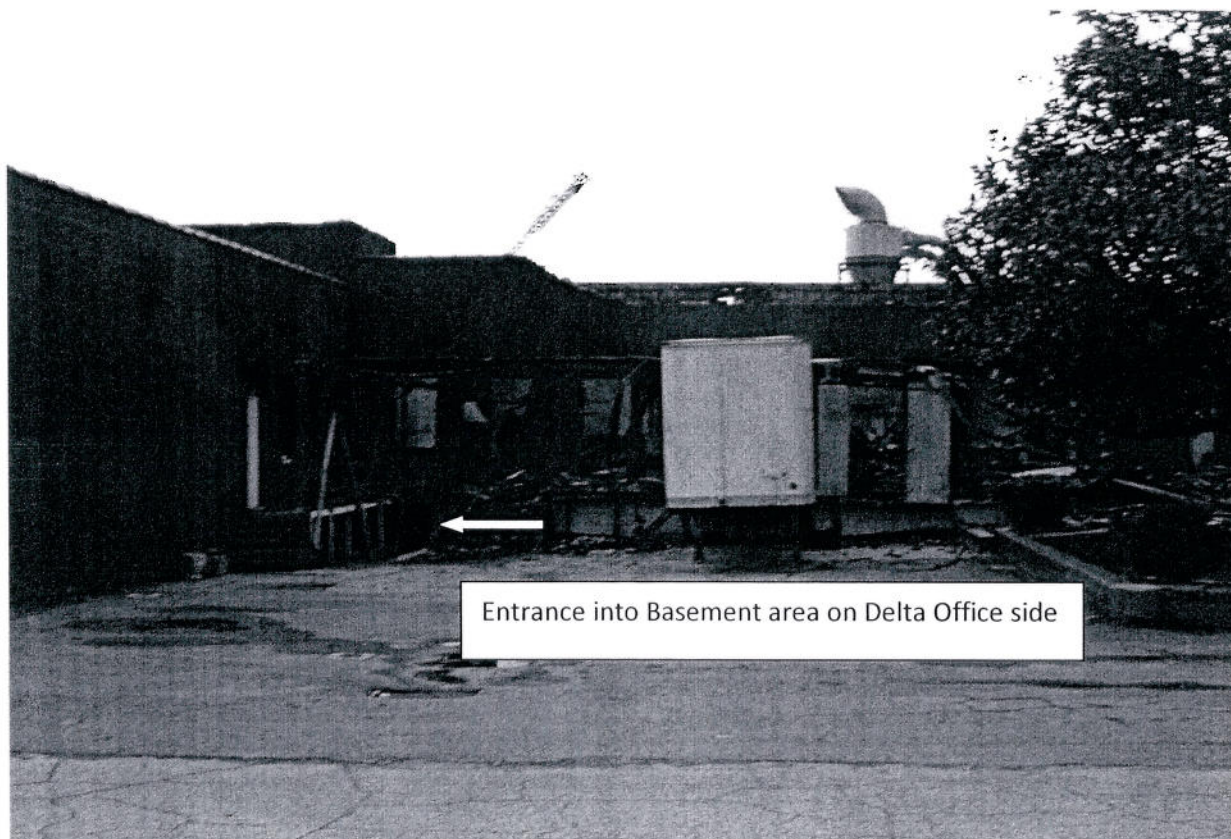
Entrance into Basement area on Delta Office side

Photo "B" - View of Delta Side Office leading into the Basement.
